RECESSED LOCOS SCHEME
(BEFORE FIELD OXIDATION)

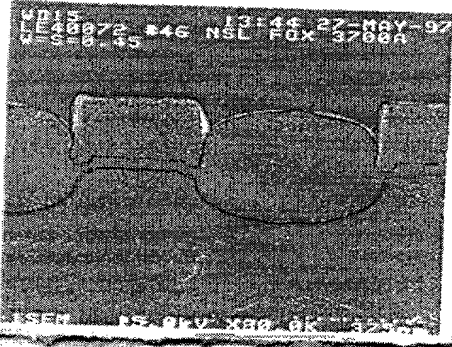
fig 5B. (process SEM cross-section)

由fig 5B可看出完全没有 bond's break encapsulation (BBE).
(做 0.3um 64M DRAM).

=> 此為長FOX之後的SEM圖.

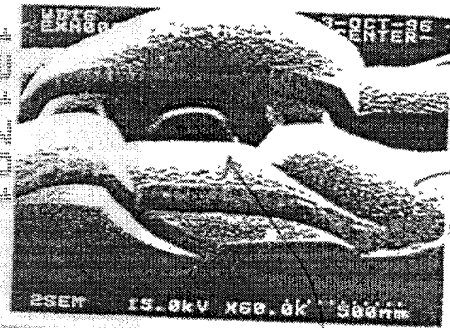
fig 5C. active area.
(process SEM cross-section)

field oxide.

由fig 5C的立體照片,可看出最後長出來field oxide
的樣子,也証明沒有BBE,同時長出來field ox
也夠厚,沒有shrinking effect.

=> 和fig 5B相同,只是拍攝成立體圖.

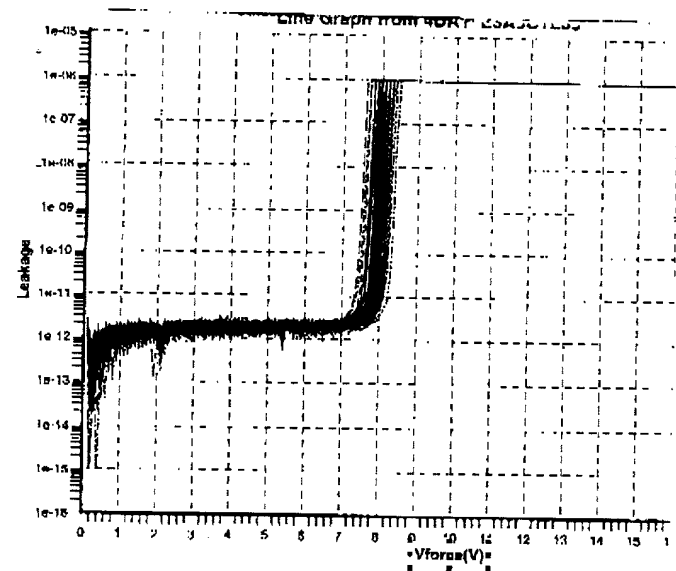
fig 5D. (electrical monitoring)

從fig 5D可看出

well junction measurement results
show that no silicon defect was induced by
isolation process.

⇒ 電信測量圖 (做完 isolation process 之後測的)。
